05 / PREMATURE FAILURE IN BEARINGS

BUSHING INSTALLED WITHOUT THE SHAFT O-RING.

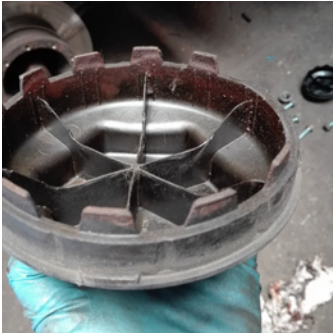
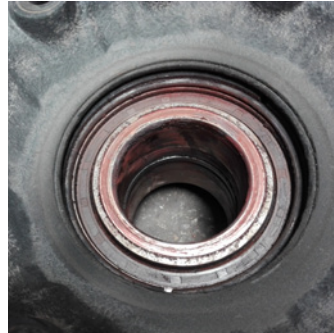
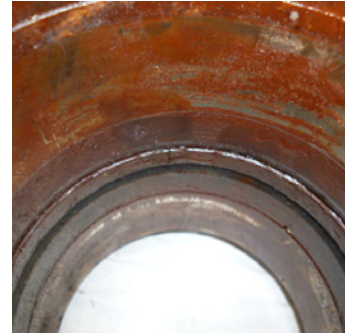
FAILING TO REPLACE THE CAP AND O-RING WITH NEW ONES.

Every time you disassemble the bushing, always replace the caps and o-rings with new ones. This way, you will ensure bearing tightness and protection from external agents that may damage it.

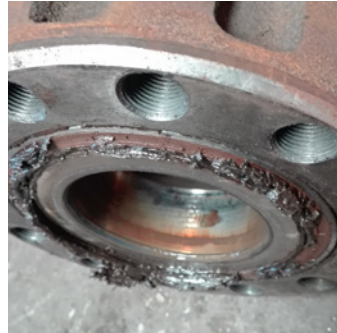
(F1)

- The bushing cap was not installed with the O-ring or the o-ring and cap were not replaced with new ones.

- Over time and due to normal wear and tear, the cap may lose tabs (F1), developing play and the possibility of getting lost, additionally, over time, the o-ring deteriorates and leaks.
- Without the cap, the bearing is exposed to the elements. Water and dirt can enter the bearing, producing the liquefying of the grease, loss of lubrication, oxidation and, finally, bearing seizure.
